ONTARIO Roofing NEWS

project profile

Nightmare On Yonge Street

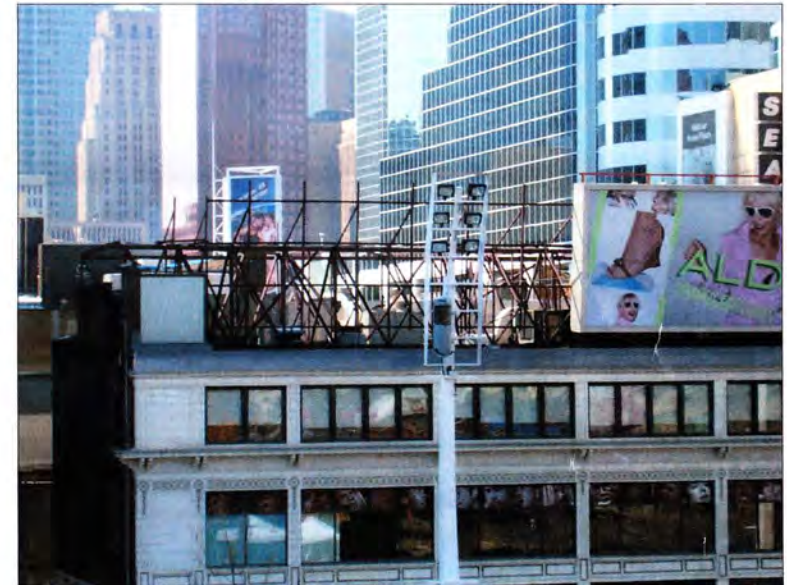
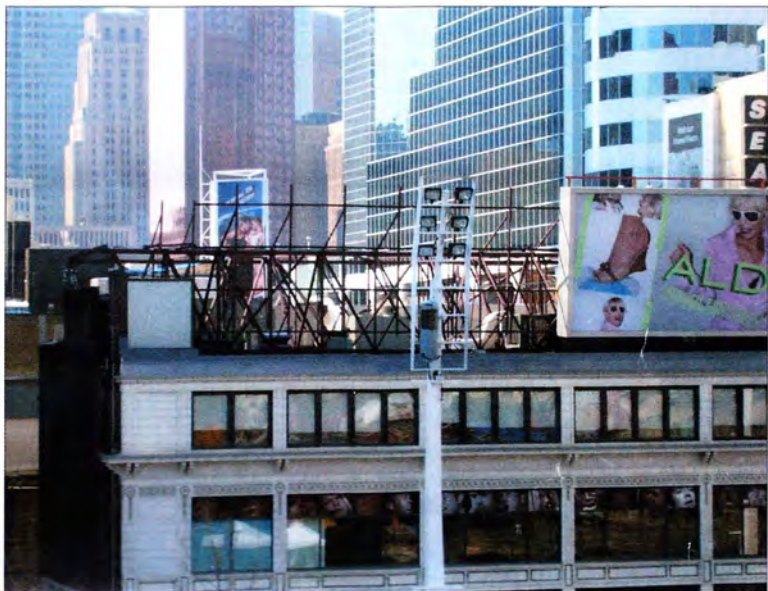
Now getting back to those billboards, can you possibly believe that the maze of structural supports built over this roof are there

for the sole purpose of supporting those massive beacons of advertising? Clearly the roofing system on this building has not been

a priority.

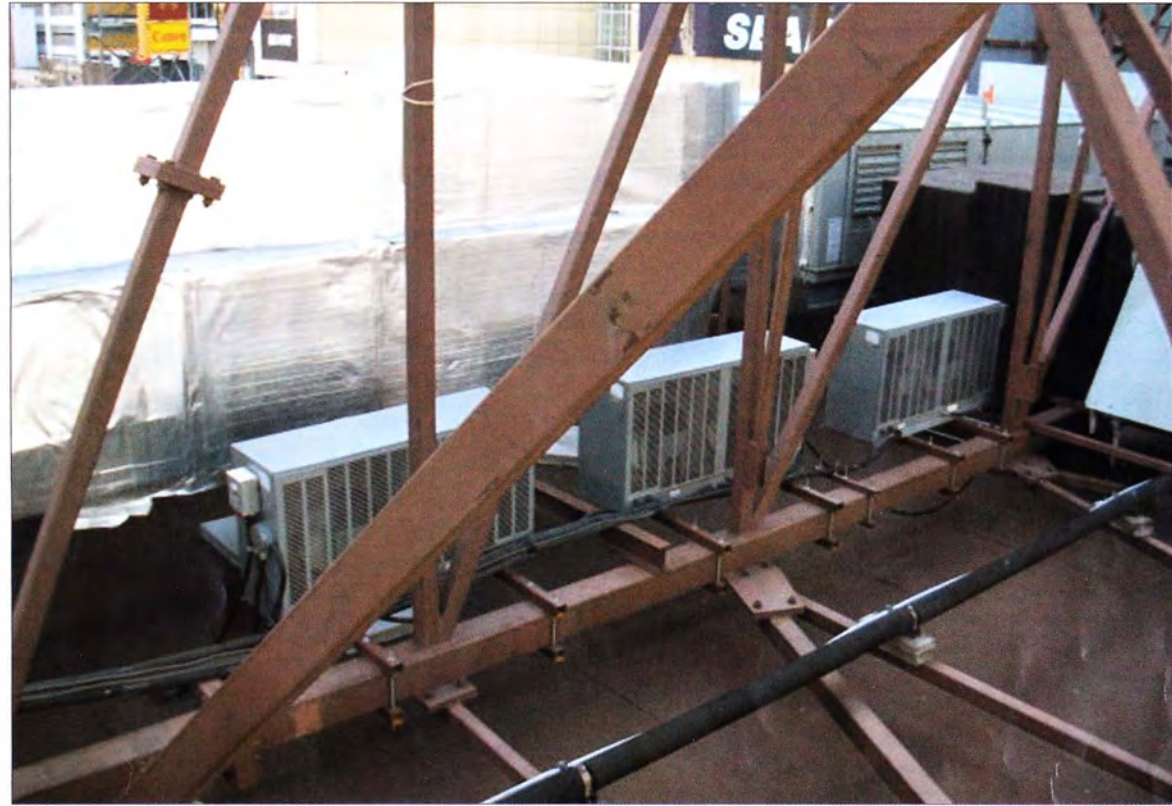
As you can see from the pictures, the roof has a number of HVAC units. These typically need to be raised so that their curbs may be flashed with membrane flashing and metal counter flashings. In an attempt to simplify this re-roofing process and any future re-roofing required, Dean-Chandler came up with the brainwave of lifting both small and large units up off their

curbs and resetting them onto the billboard steel structure. A structural

engineer first had to determine that the steel could structurally support the weight of the units. Along with the HVAC equipment, all gas lines had to be raised and connected to the steel structure as well.
